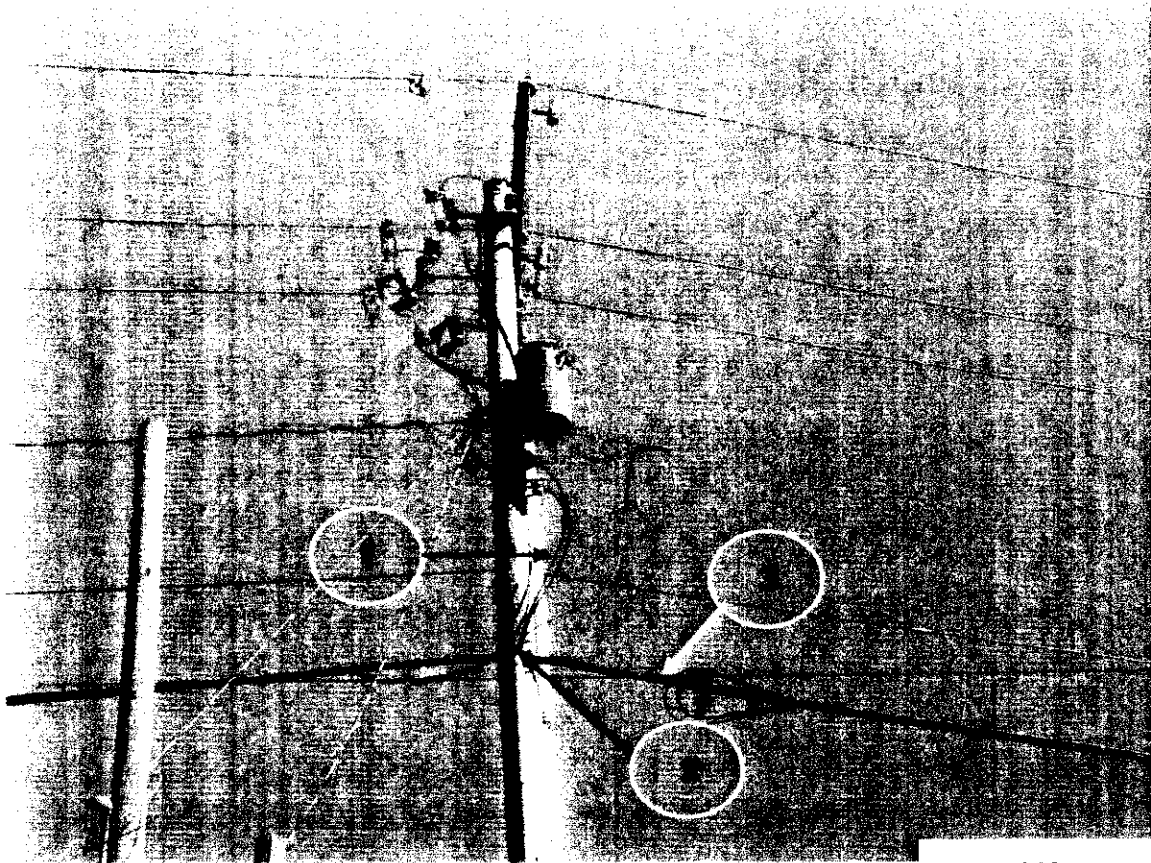
- 11A -

In this photo, which I took, EAI placed an underground service up the pole outside cable (Arrow #1). As a result, the cable operator cannot move or work on this cable without the assistance of power company crews. The Comcast cable is pinned to the pole by electric wires (Arrow #2) which, by code, should be 40" above the cable television line (the bottom black line with the fiber "snow shoe" (Arrow #3)). It is obvious from the position of these facilities that cable was installed first. Despite pleas from Comcast, EAI still has not corrected this clear hazard. Location: Little Rock University Ave.

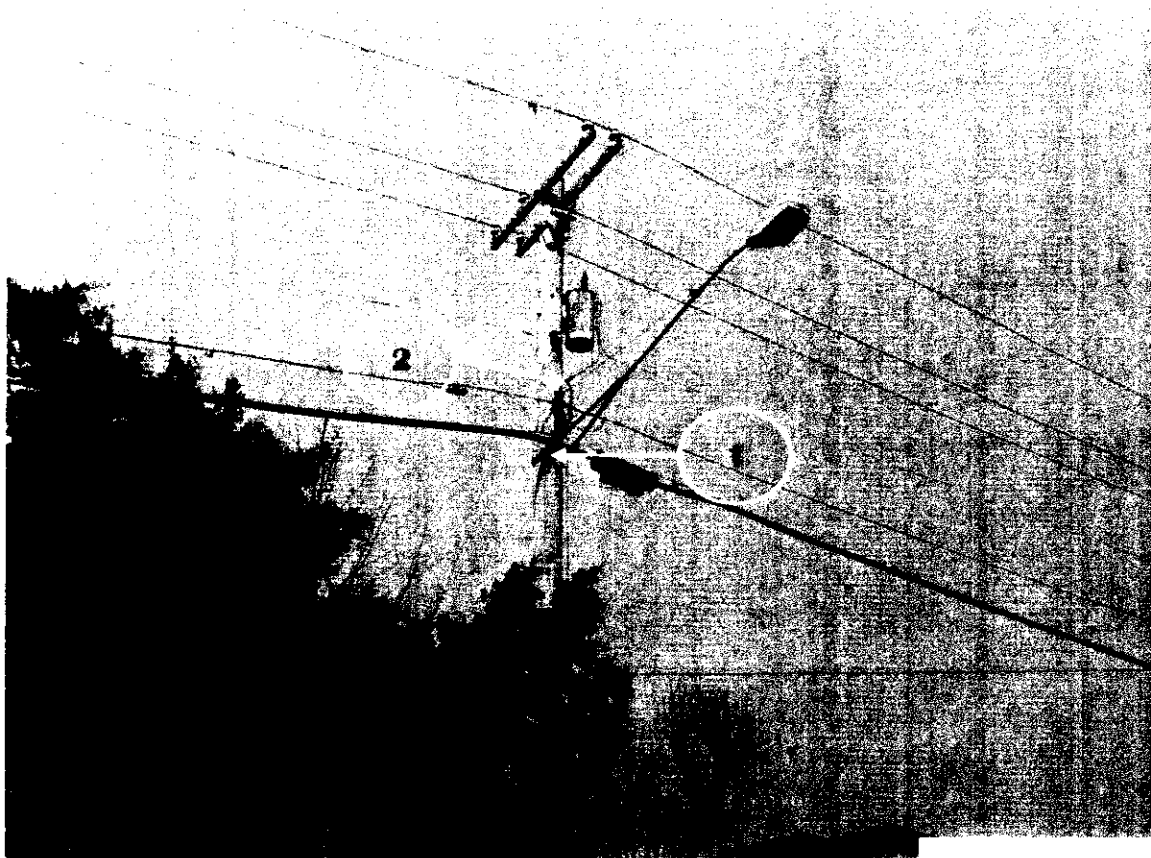
- 12A -

This photo, which I took, shows an EAI street-light bracket installed both below the telephone facilities (Arrow #1) and above the cable television facilities (Arrow #2). It is very obvious that this street light bracket could not have been installed before the cable television and telephone attachments because the street light brackets are installed *on top* of the communications facilities. This is one of what I would estimate to be many thousands of examples in Arkansas that contradict EAI's central assertion that electric facilities always came before cable. Location: Jacksonville, AR, N. First St.

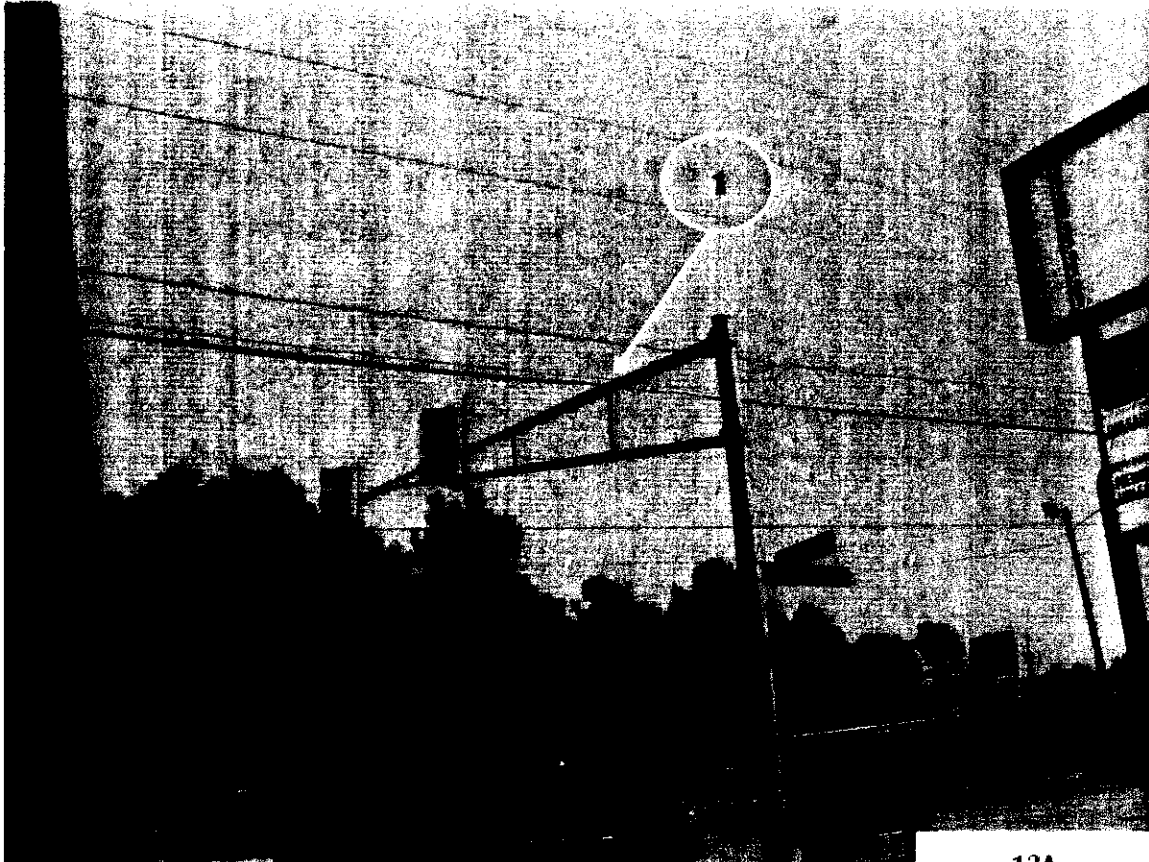
- 13A -

This photo, which I took, shows a common problem throughout Little Rock where new traffic signals are installed on long horizontal arms over the roadway by governmental agencies. In so doing they push the cable and/or telephone facilities up, often creating violations with cable tv, telephone and electric lines (Arrow #1). These types of problems need cooperation and good communications directed and facilitated by the power company. Location: Little Rock Geyer Springs Rd. at Forbing Rd.

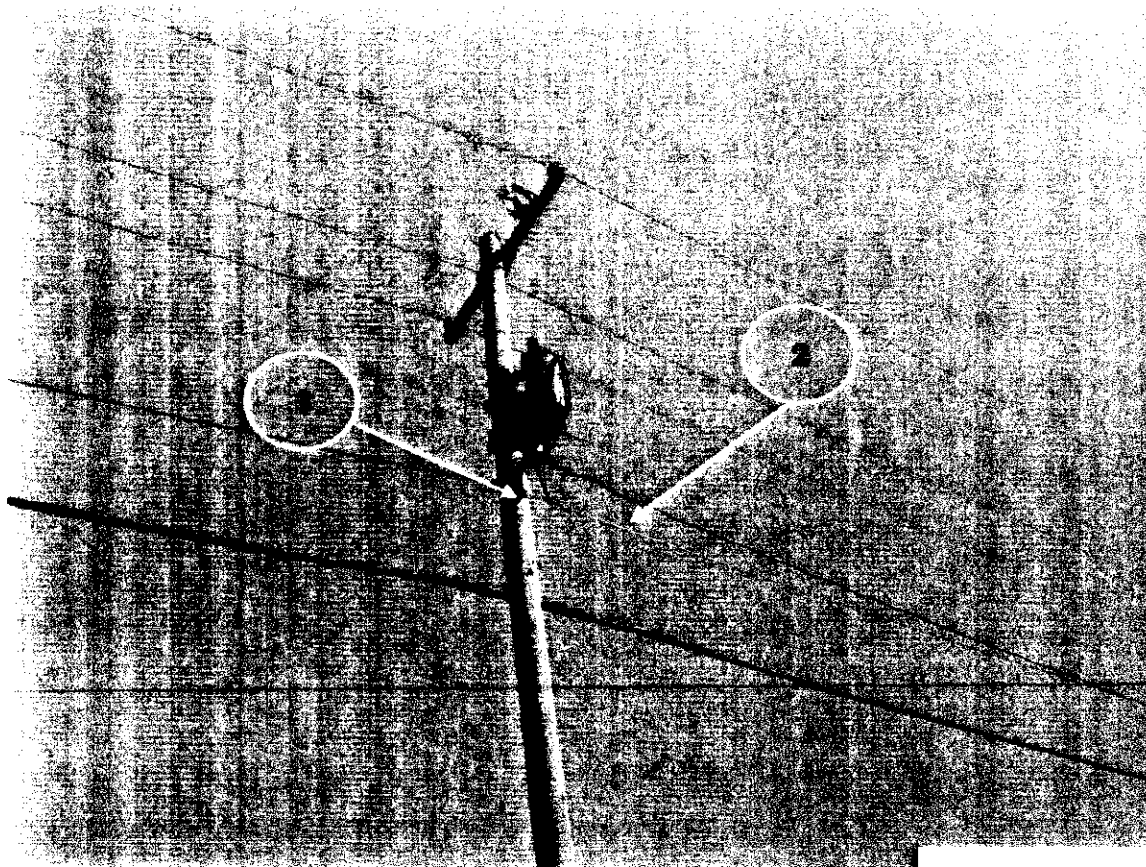
- 14A -

In this photo, which I took, EAI has installed a new flood light bracket (Arrow #1) below a fiber-optic cable (Arrow #2) now owned by a competitive telecommunications company as well as triplex secondary to the light on the next pole installed by EAI in violation. As is pointed out elsewhere Entergy installed this fiber optic cable (Arrow #2) in clear violation of the NESC at a time in which it was a part owner of the fiber venture that used to own this fiber strung throughout Little Rock (often in violation). Location: Little Rock University Ave.

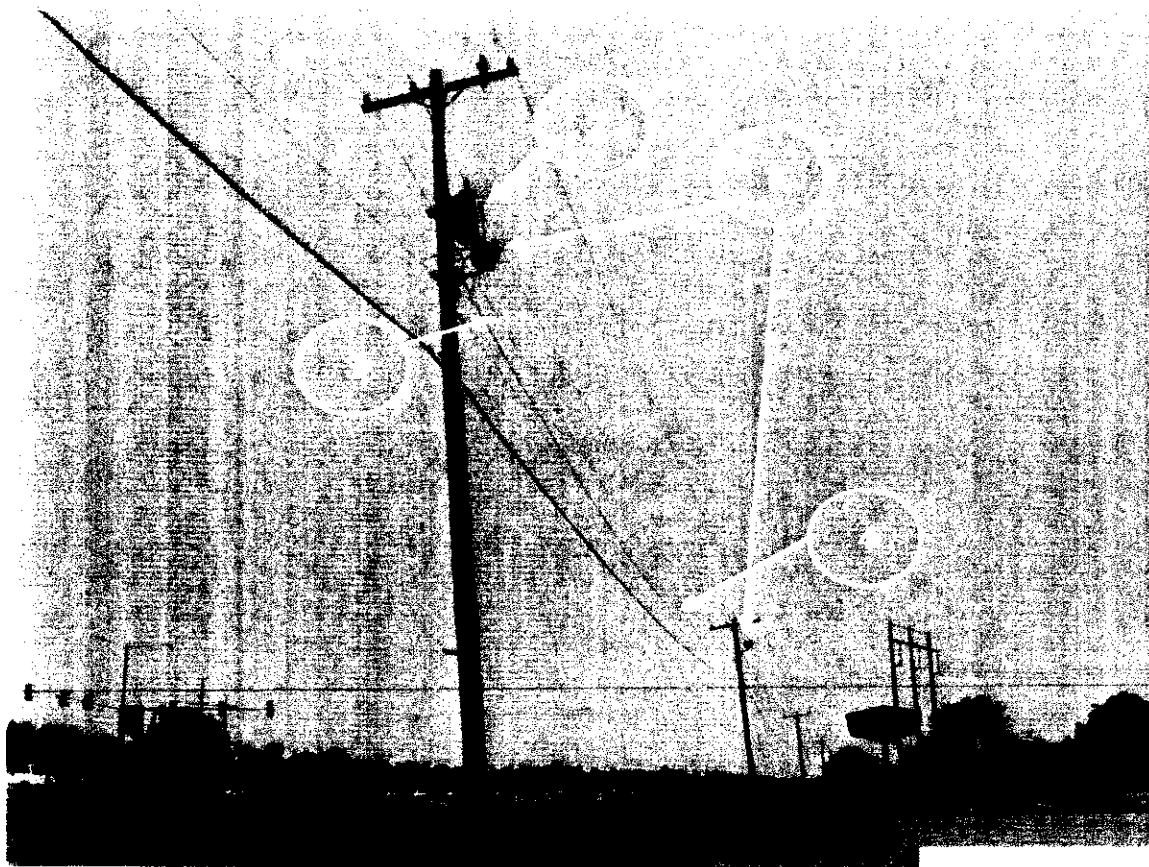
- 15A -

In this photo, which I took, the new flood lights on both of the poles shown (Arrows 1) are the only things served by the transformer (Arrow #2). This indicates that all these facilities were placed long *after* cable was in place. (I address this issue in greater detail when considering ACTA's False premise Number 3) EAT's triplex wire (Arrow #3) from the transformer pole hangs **below** the fiber-optic (Arrow #4) in the span in violation. It should be 30" **above** this fiber-optic cable. A fiber optic cable may be installed in the electric supply space (if non-conducting) or in the communication space but not in between, which is the communications worker safety zone. These fiber-optic facilities used to be part-owned by Entergy. Location: Little Rock University Ave.

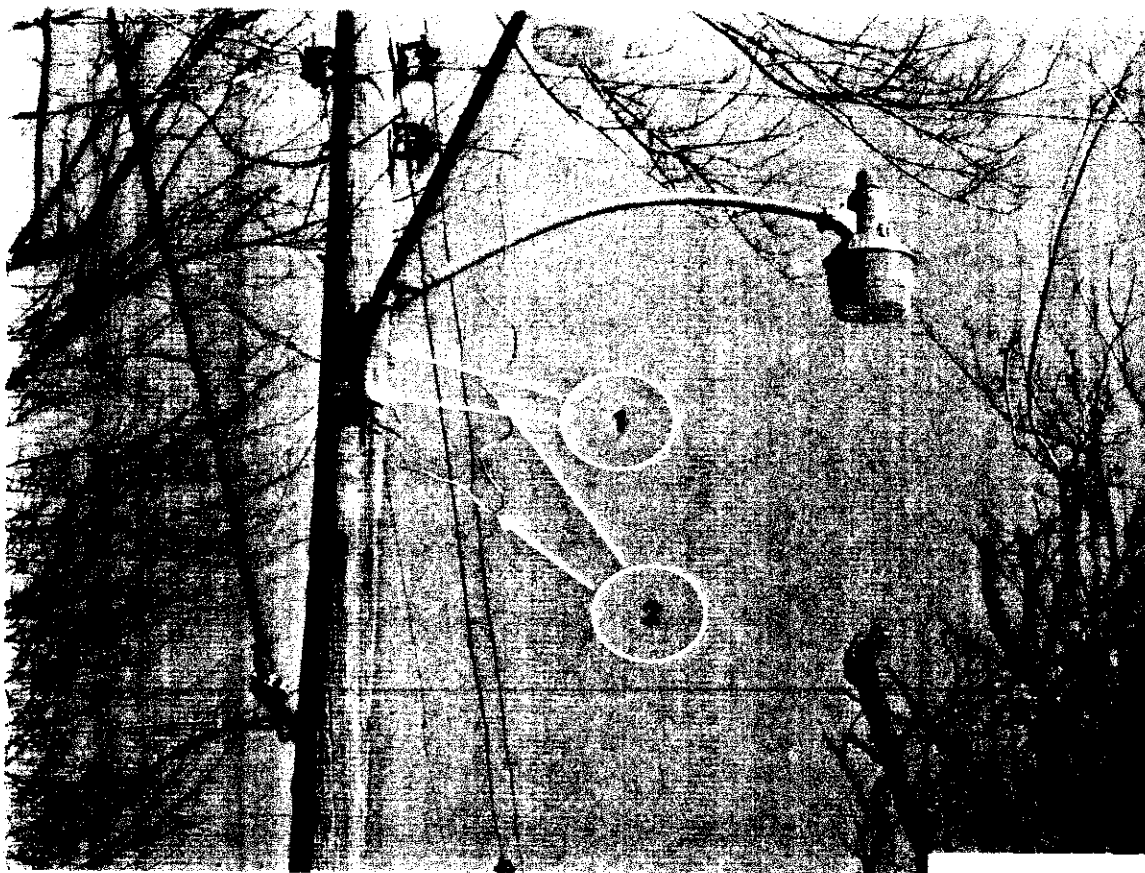
- 17A -

This photo, which I took, shows two street lights. The brackets are not grounded (Arrow #1). This violates EAI construction standards which are shown in the diagrams attached to some of its agreements. Even though EAI and USS purport to be concerned about plant safety, USS did not check for this EAI violation. Twenty inches of separation is required for un-grounded street light brackets. In addition, the "romex" type wire to power the lights hangs down beside the pole in violation (Arrow #2). Location: Little Rock 10th St rear of 928 Townsend St.

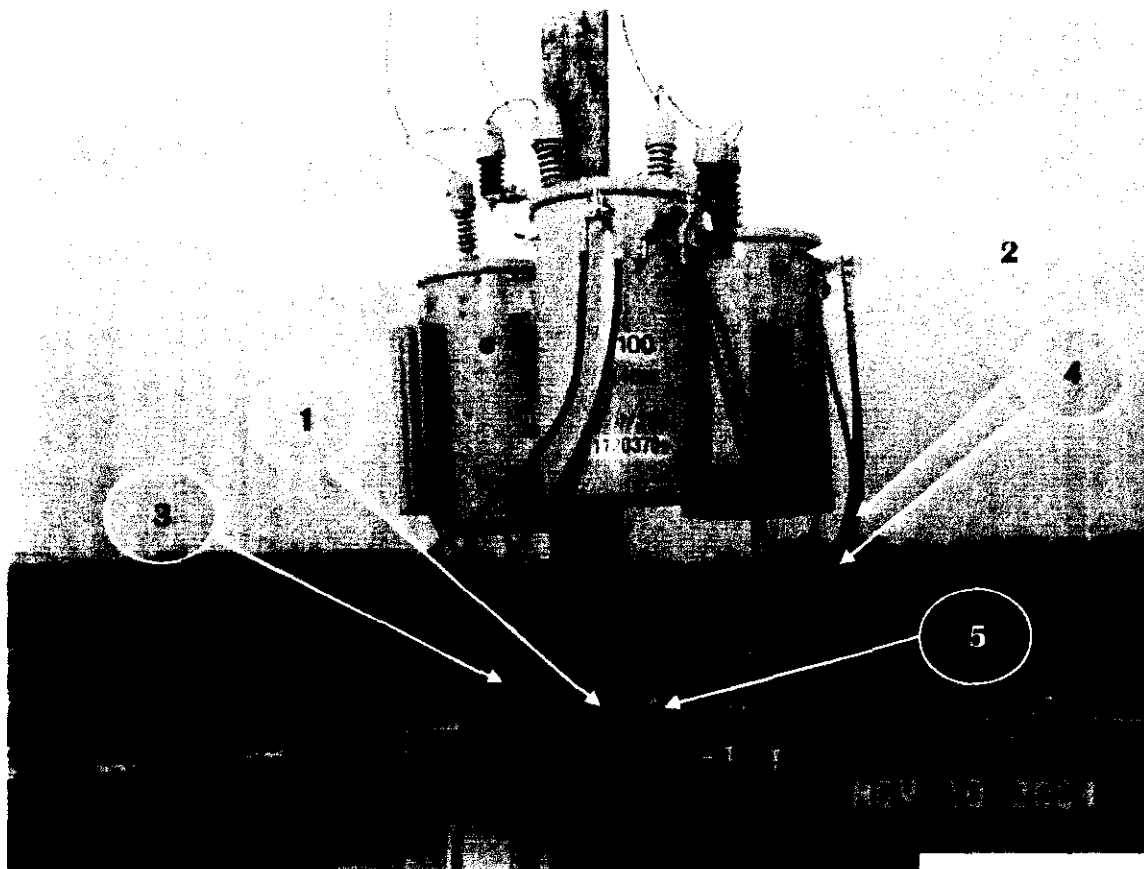
-- 22A --

One of Entergy's central contentions is that electric facilities always are on the poles first and that cable facilities always come later. This is so it can argue that whenever there are clearance violations, they have been created by cable. This photo shows that this is not true. The three-phase transformer bank depicted in this photo were installed within the last several months to provide electric service to a new McDonalds restaurant. The poles and the cable television attachments (Arrow #1) were installed before the offending riser conduits and transformers. Cox was attached in compliance. The new transformer cans (Arrow #2) the grey "riser" conduit (Arrow #3) and the electric wires (Arrow #4), were installed after cable. There are no more than a few inches of separation between the hot electric wires coming out of the riser (Arrow #3) and Cox's facilities (Arrow #1). The NESC mandates that there should be 40 inches between the riser cable and the Cox attachment. I believe that this pole was set by EAI to provide adequate vertical clearance above the new driveway at the McDonalds. These photos were taken in the direction of Jeff Gould of Cox.

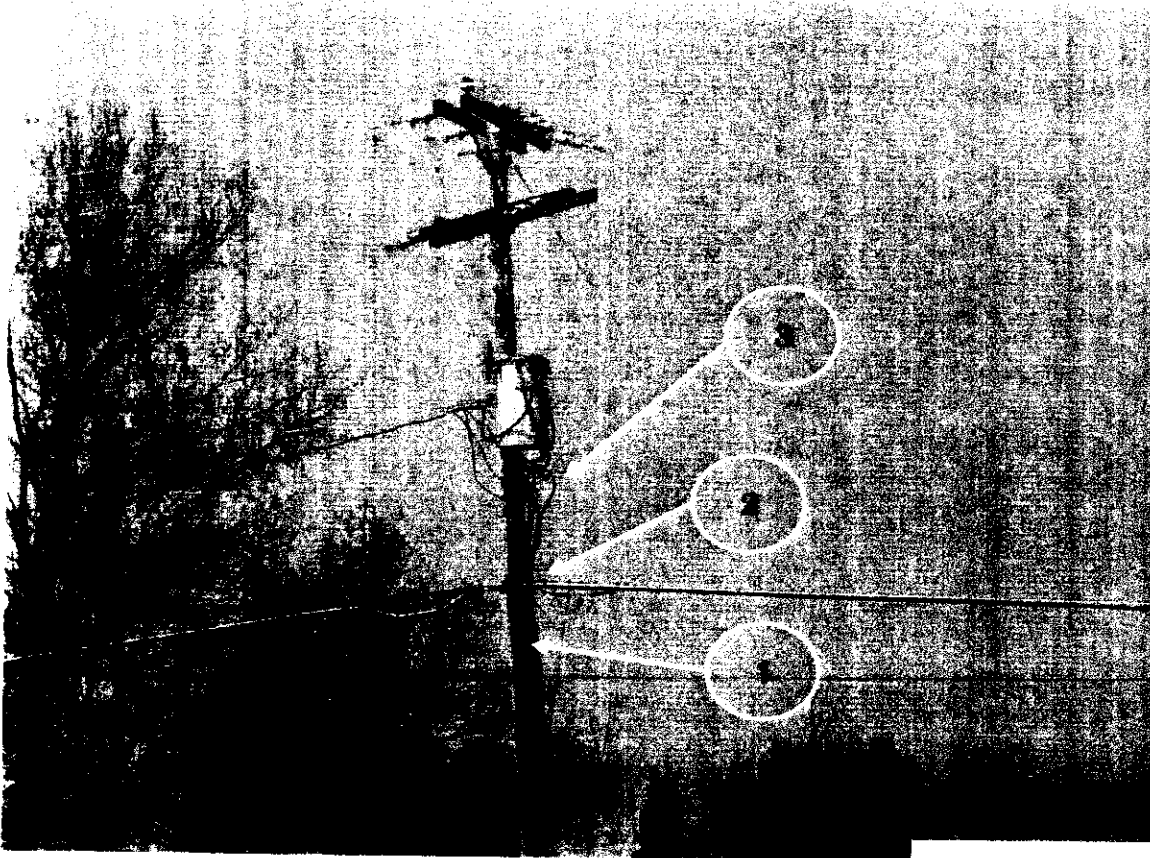
- 23A -

This photo, which I took, presents another good example. It shows an EAI secondary underground service riser pipe (Arrow #1) stopping more than 12 inches **below** the cable television facilities (Arrow #2) located on this pole. The NESC requires this electric conduit to be 40 inches above cable. You can see that there are two underground service drops running from the transformer and the loops coming out of the transformer are very sloppy (Arrow #3). Putting the proper length of conduit and placing the loops correctly could have been done easily. Underground service risers such as these are usually added long after the cable television facilities have been installed. Other examples of poorly installed electric facilities that went in long after cable appear in the next photo. Location: Jacksonville, AR Alley between N. Bailey Blvd & N. James St.

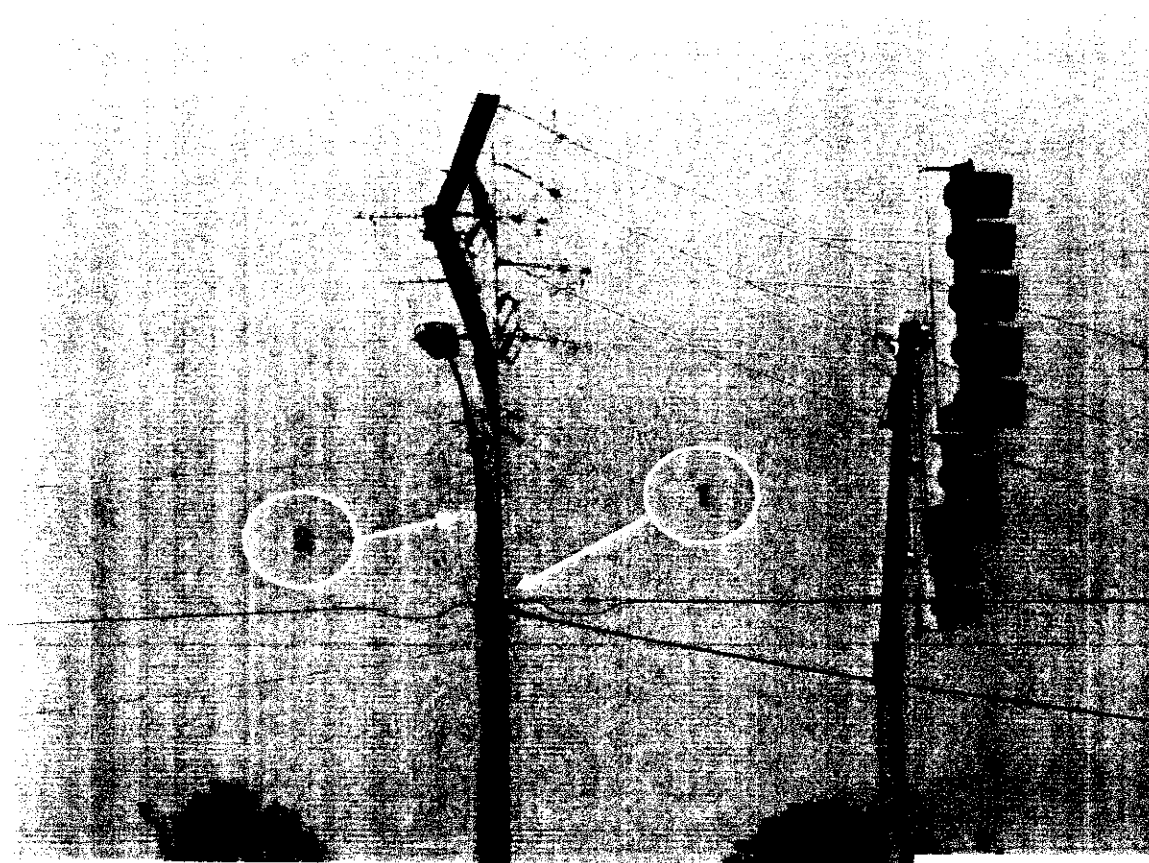
- 24A -

This photo, which I took, shows an EAI service to a new traffic signal. Electric power to supply the traffic signal is wired by the governmental agency or contractor. Metal conduit with two wires for 120 volt power is extended up this pole (Arrow #1). In this case, EAI should not have made this connection because of this NESC violation, and required the conduit owner to extend the conduit to 40 inches above cable television. You can see several exposed wires hanging beside the pole next to EAI's secondary on the left of the pole (Arrow #2). This is a blatant violation of the NESC's 40 inch rule. Connections to a new service (in this case traffic) must be 40 inches above cable. EAI should remedy this by placing a "u-guard" (which is essentially one-half a plastic conduit over the traffic signal leads, or require the owner of the traffic signal to extend the weather head up to 40 inches or more above cable. Location: Jacksonville, AR W Main St at N. Bailey Blvd.

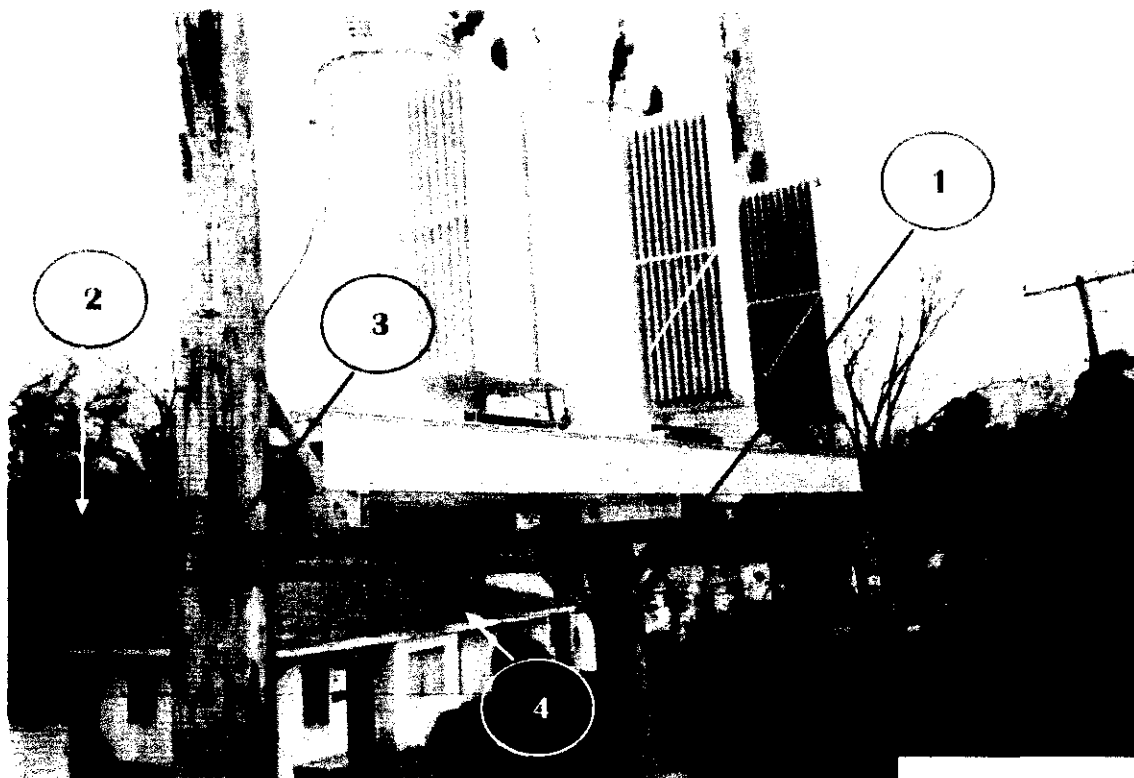
- 26A -

This photo, taken at the direction Jeff Gould of Cox Communications, shows a multi-pole platform-mounted voltage regulator that Entergy has installed *after* the installation of communications facilities. Note on the center pole the steel bracket (Arrow #1) that has completely boxed in the two sets of communications lines on the poles. The top line is the cable attachment (Arrow #2). EAI set new poles, pulled Cox's cable down and physically forced it beneath a bolt through one pole (Arrow #3). EAI built its neutral wire below the telephone cable (Arrow #4). Neither cable tv nor telephone is attached to either pole or bonded to the pole grounds. This creates a very dangerous situation. In installing these facilities Entergy has violated NESC rules, cable tv, telephone and EAI standards. This photo shows that EAI has a lack of understanding of the NESC, lack of training, no inspection of new construction and a complete disregard for users of the communications space. Electric companies, like communications companies from time to time must add new facilities to their networks. But they must do so in a way that respects the rights of others to occupy the poles, including providing adequate notice of the work that they wish to perform on the poles.
